Abstract Presented to the Graduate School of the University of Florida in Partial  
Fulfillment of the Requirements for the Degree of Master of Engineering

USING REINFORCED EARTH WALLS FOR BLAST MITIGATION

Ronald L. Pieri

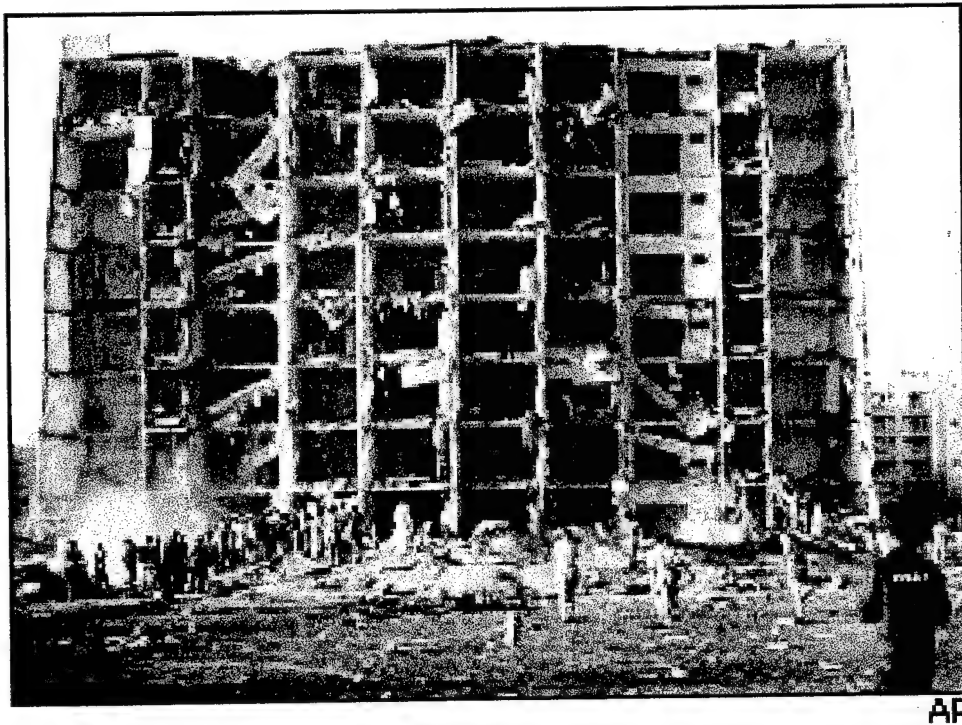
On June 25, 1996, a terrorist truck filled with explosives detonated outside the perimeter of Khobar Towers, Dhahran, Saudi Arabia. This facility was housing United States and Allied Forces supporting Operation Southern Watch, the mission for aircraft operations over Iraq. The size of the bomb has been estimated between 3,000 and 30,000 pounds of trinitrotoluene (TNT). However, the task force evaluating the bombing determined the explosion was more likely on the magnitude of 3,000 - 8,000 pounds and are using 5,000 pounds as the model to protect future structures against.

Figure 1: Khobar Towers After Bombing

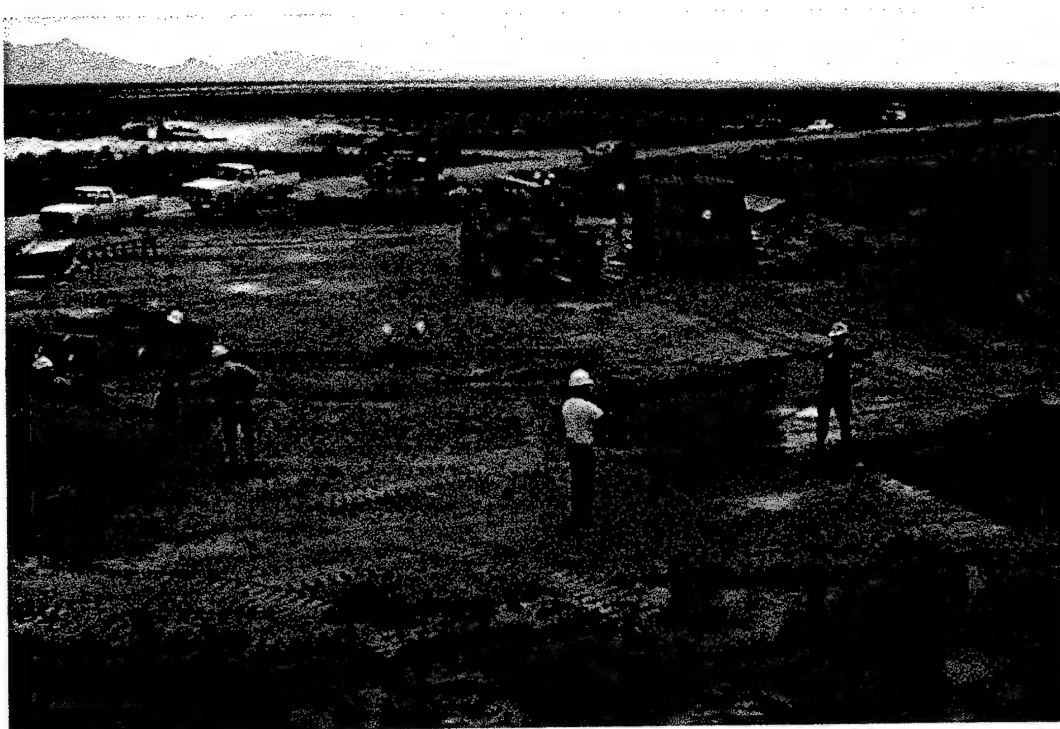
After attaching the erosion mat to the biaxial geogrid, the next step was to position the geogrid. The shape looked like a horseshoe since the initial plan was to have three 80° slopes. The geogrid was positioned so that four feet of the biaxial geogrid would rest beneath the first lift.

Photograph 5.1: Placing Biaxial Geogrid

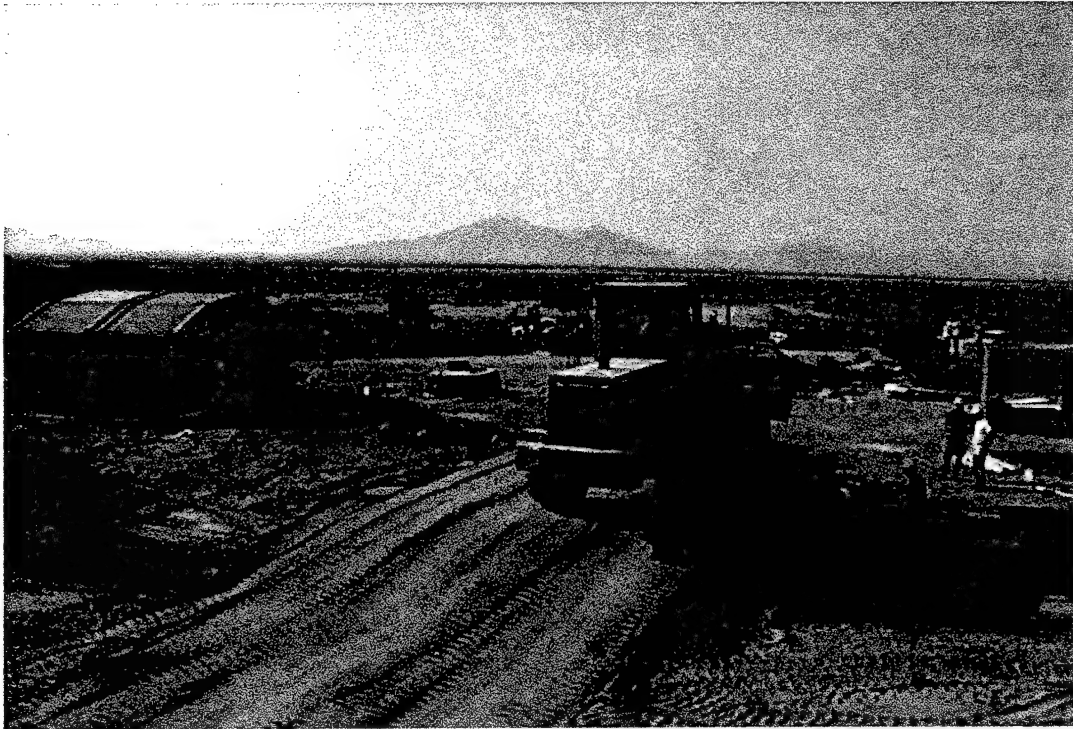
The next step was to place the last twelve inches of fill so that the first lift could be wrapped with the biaxial geogrid. The loader system was repeated until the lift reached three-feet in elevation. The lift was brought to approximately 40" in elevation. Next, the loader compacted most of the area but stayed away from the edges.

Photograph 5.4: Compacting Lift #1

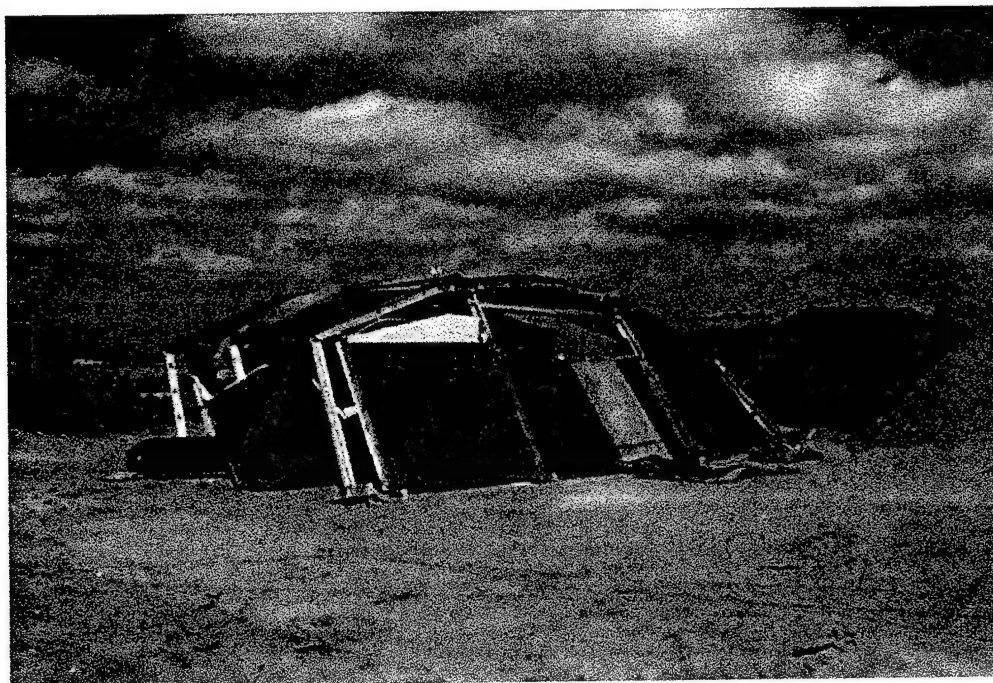
Photograph 6.2: GPS 2 after the blast.

The photographs depict what Table 2.3 predicts for butler buildings and tent structures. For expedient facilities, failure could be a subjective criteria. Failure could be considered a certain amount of deflection to engineers, but it could also be determined by whether or not the structure is still standing. With respect to the DIVINE BUFFALO Test, all the facilities were left standing but they cannot be considered functional. For this report, all the facilities failed due to the blast effects.

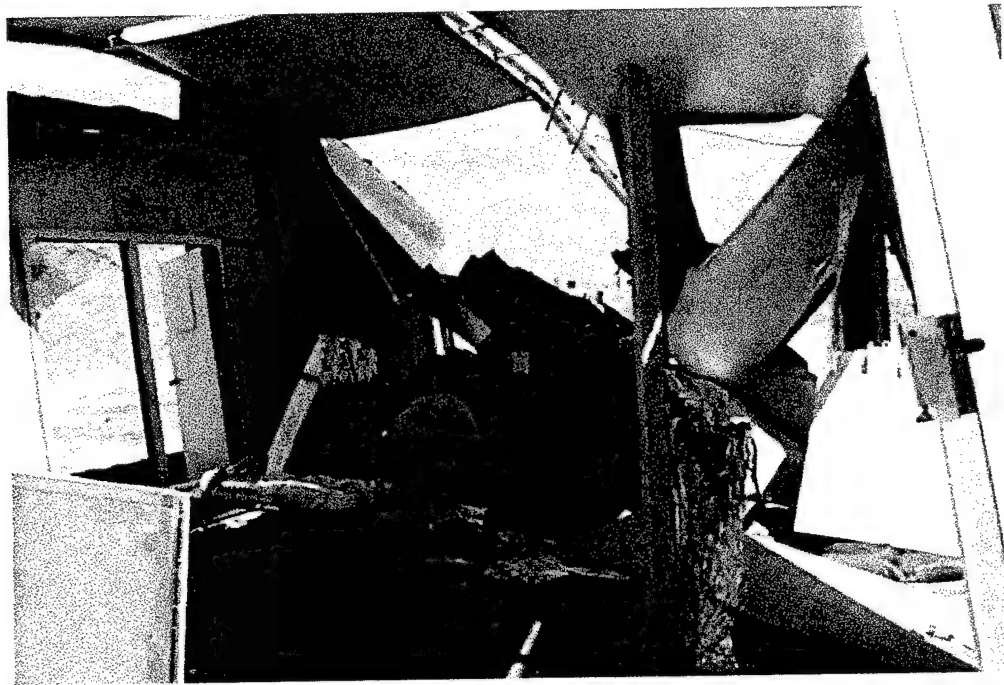
Photograph 6.5: Interior of GPS 1 after the blast.
